PRELIMINARY REPORT
FOR
COMMONWEALTH OF PUERTO RICO
DEPARTMENT OF PUBLIC WORKS
AND
PUERTO RICO PLANNING BOARD

FLOOD CONTROL STUDIES
HUMACAO RIVER
HUMACAO, PUERTO RICO

CESAR S. CANALS ASSOCIATES
CONSULTING ENGINEERS

APRIL, 1969

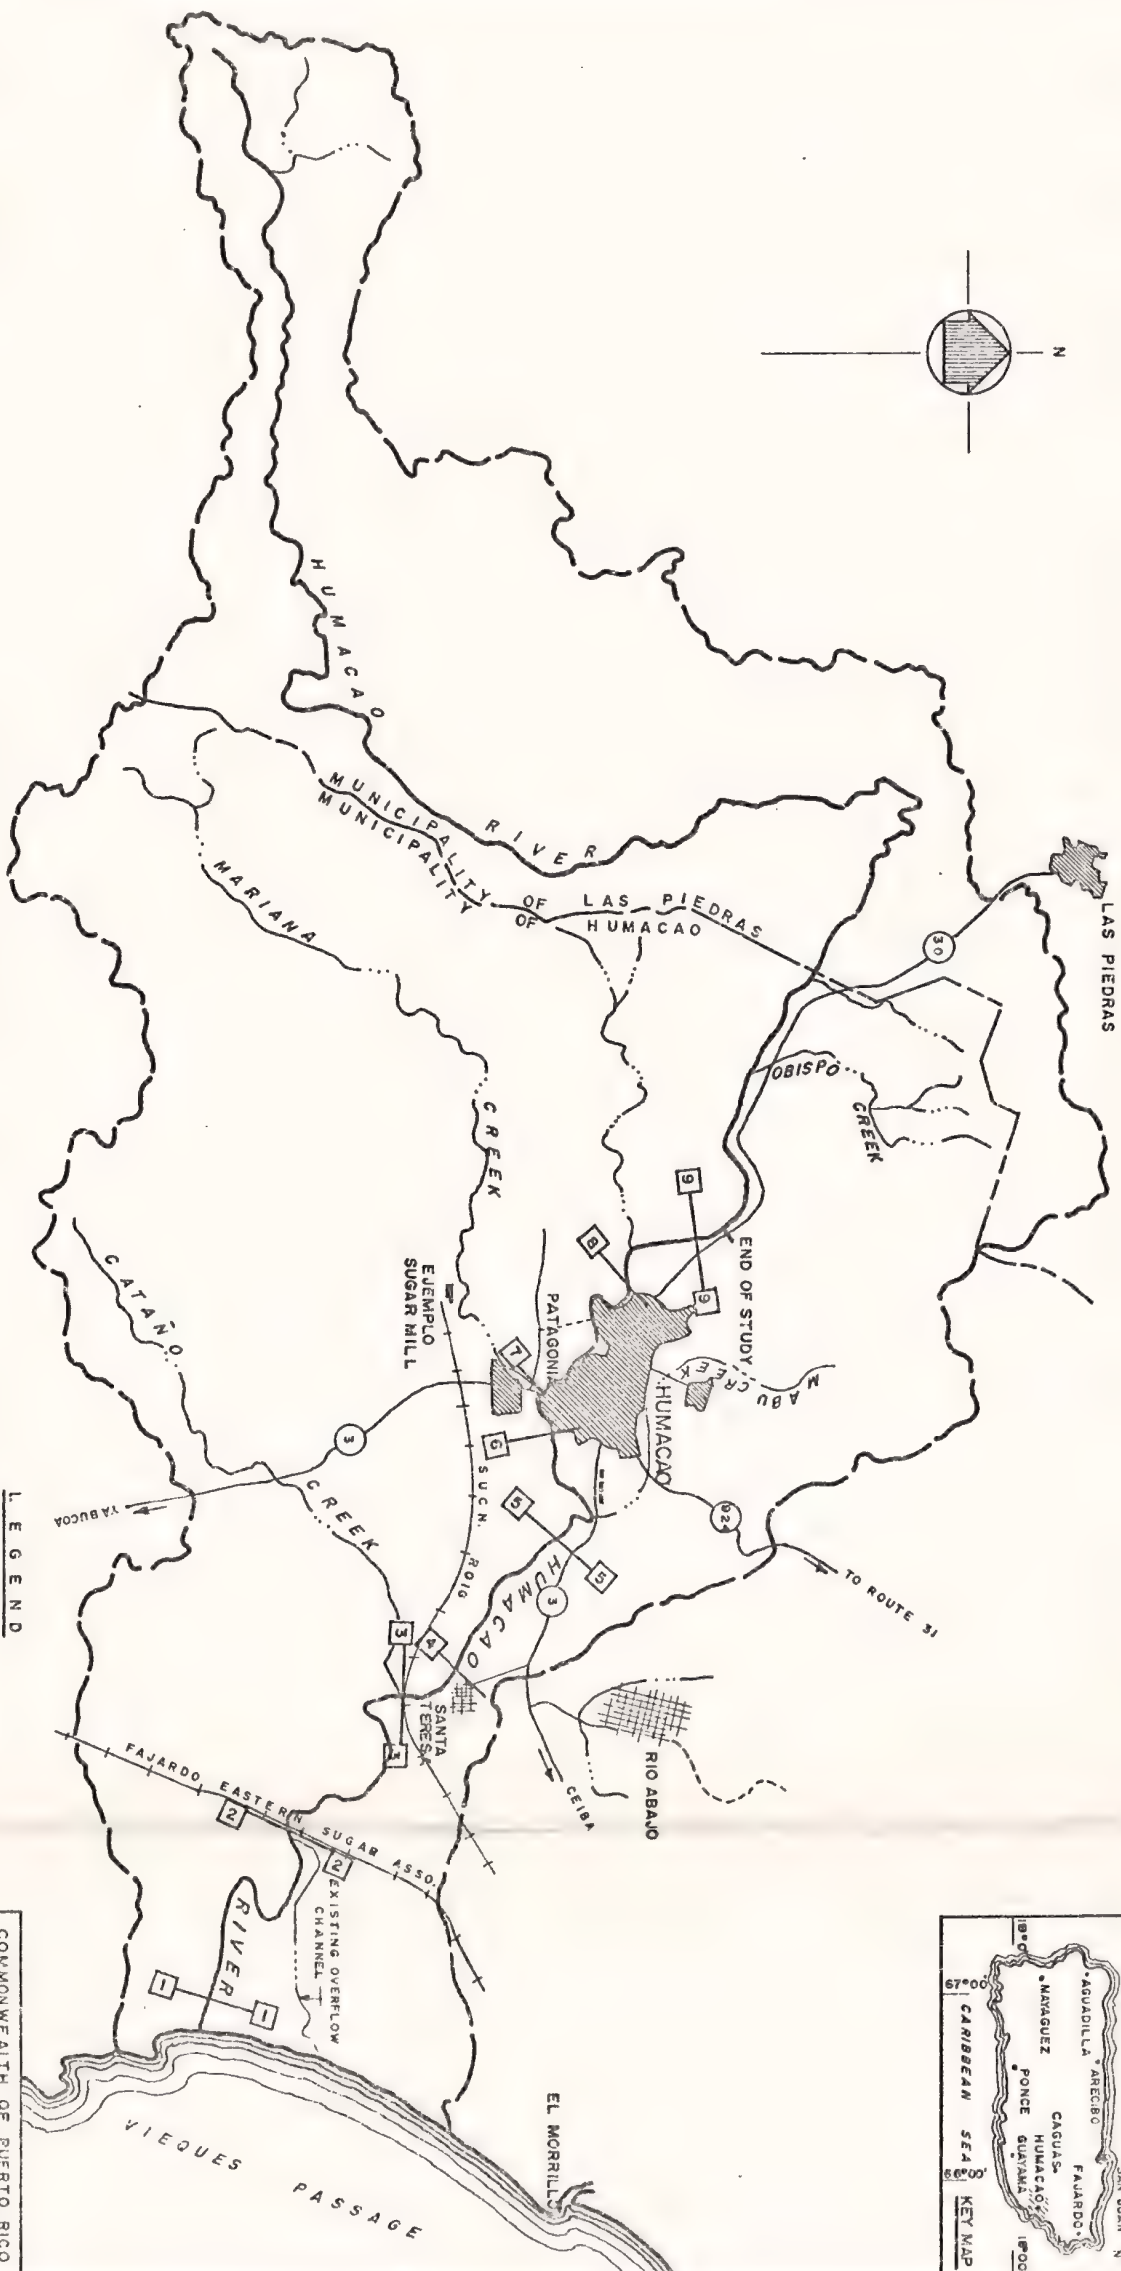
WATERSHED & STUDY AREA  
CESAR S. CANALS ASSOCIATES  
CONSULTING ENGINEERS  
SAN JUAN, PUERTO RICO DATE: APRIL 1969

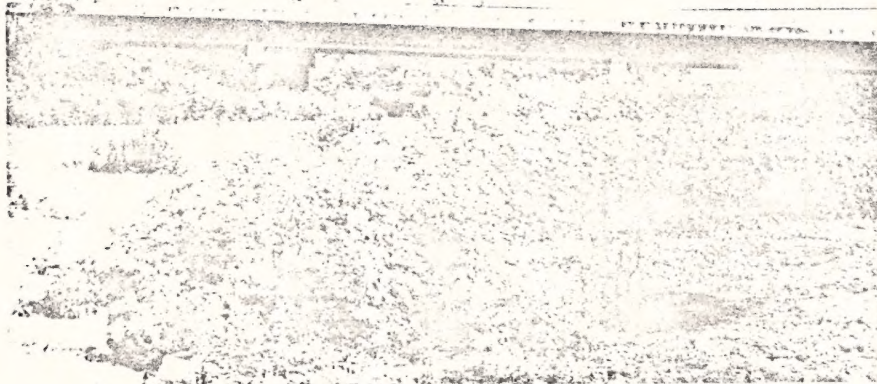
Bridge on State Route No. 3 built in 1961, after the 1960 flood washed away the old bridge at the site.

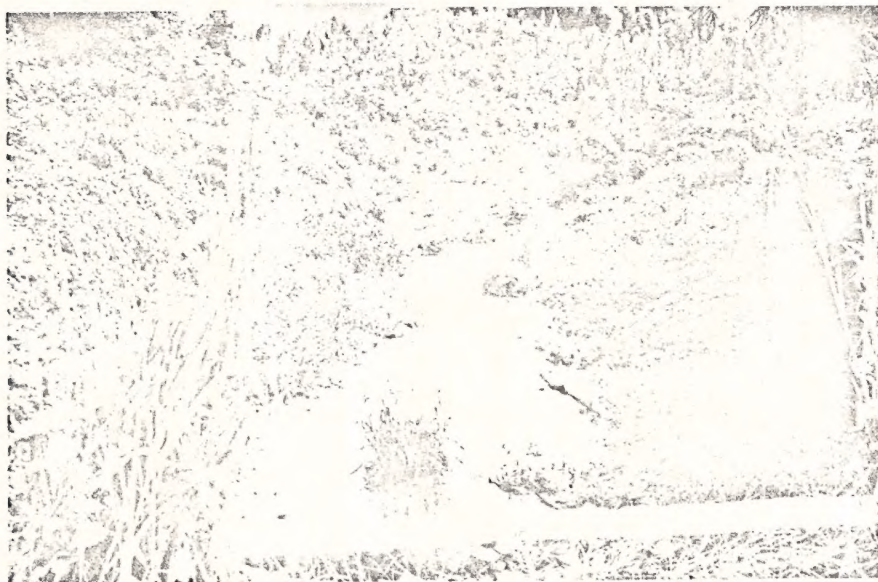
View of Cataño creek looking downstream from bridge on State Route 923.

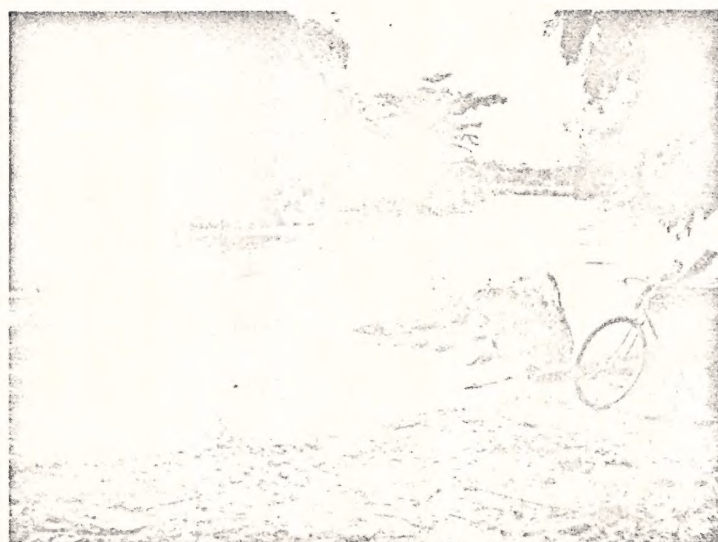
Bridge on Route 923 in Humacao spared by the 1960 flood of the Humacao River was washed out on May 21, 1969.

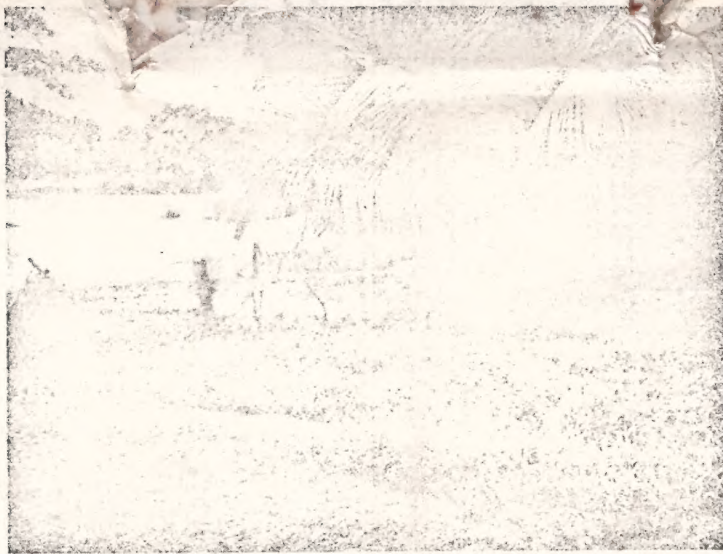
View of the confluence of Mabú creek and the Humacao River swollen by floodwaters on May 21, 1969.
